CIRCULATION CHANGE AND EBB SHOAL DEVELOPMENT FOLLOWING RELOCATION OF MASON INLET, NORTH CAROLINA

Karyn M. Erickson¹, Nicholas C. Kraus², and Erica Eva Carr³

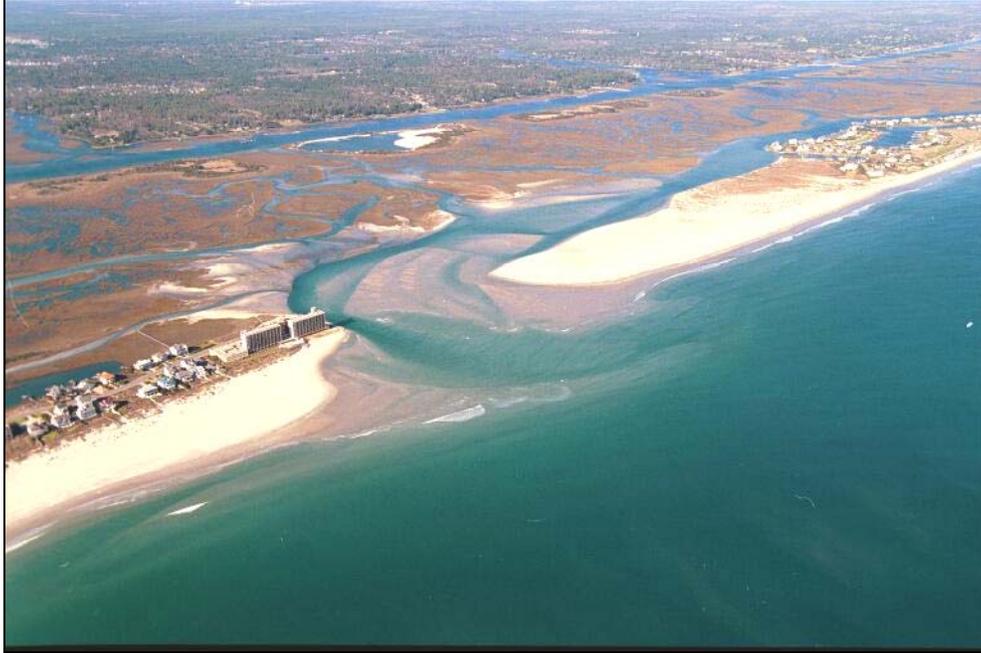
Fig. 2. Mason Inlet (Dec 2001) prior to construction of inlet relocation project.

The "imminent threat" to the Shell Island Hotel resulted in the State of North Carolina granting a variance for a permit to construct a temporary 6 m (20 ft) high, 130 m (425ft) long geotextile revetment along the hotel's foundation to prevent further movement of the inlet in 1997 (Fig. 2). The State of North Carolina's prohibition of hardened structures is an outcome of a 1985 general statute that strictly prohibits construction of hardened erosion-control structures on the ocean shoreline, except for protection of roads and national monuments. This statute prohibited placement of a terminal training groin or similar structure to control the inlet's position, thereby requiring the affected property owners to develop a long-term solution without stabilizing structures. With the impending December 2001 deadline to remove the temporary revetment approaching, and an agreement by the stakeholder group's property owners to repay the County for the costs of implementing a long-term solution to the inlet problem, New Hanover County contracted with a coastal engineering firm to begin work.

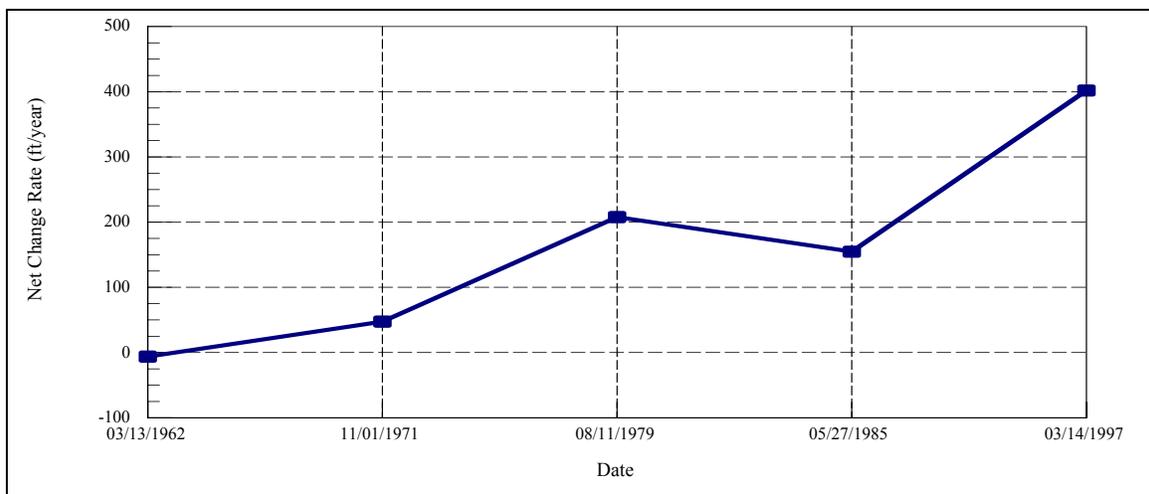
Fig. 3. Migration rate at Mason Inlet.

Mason Inlet had a history of migration and change prior to 1997 when the inlet was temporarily stabilized. Although the inlet was relatively stable between 1963 and 1977, this was followed by a period when the inlet migrated south at rates of 48 to 210 ft/year between 1971 and 1996 (Fig. 3). Between 1996 and 1997, the inlet migrated at a higher rate of 0.4 m (1.1 ft) per day, with episodic erosion events occurring during the spring tides (Fig. 4).

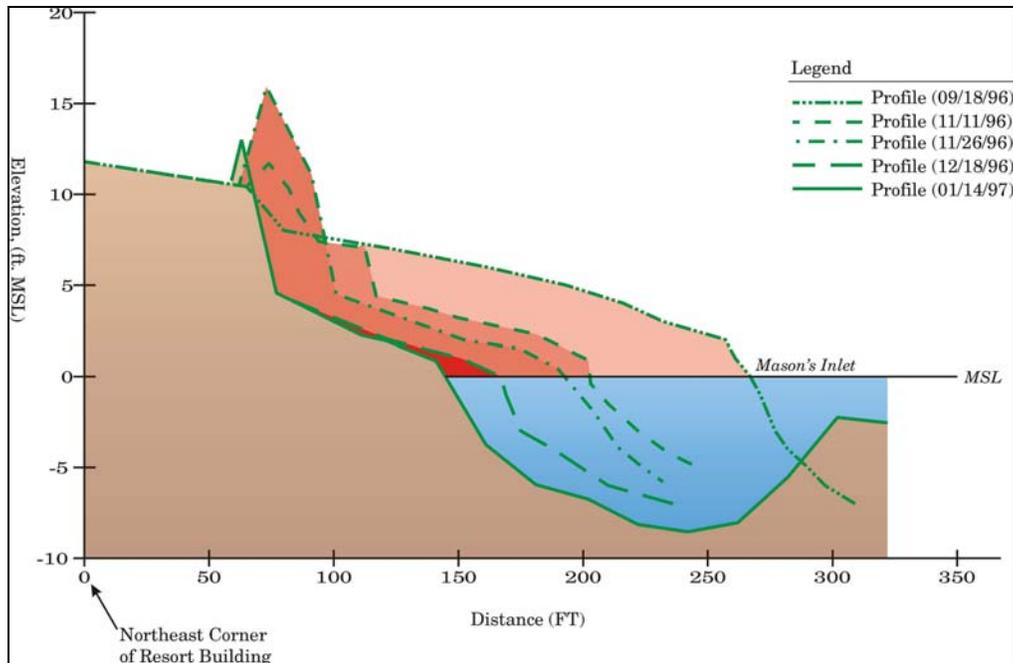
Fig. 4. Shoreline change at Mason Inlet's south channel bank (1996-1997)

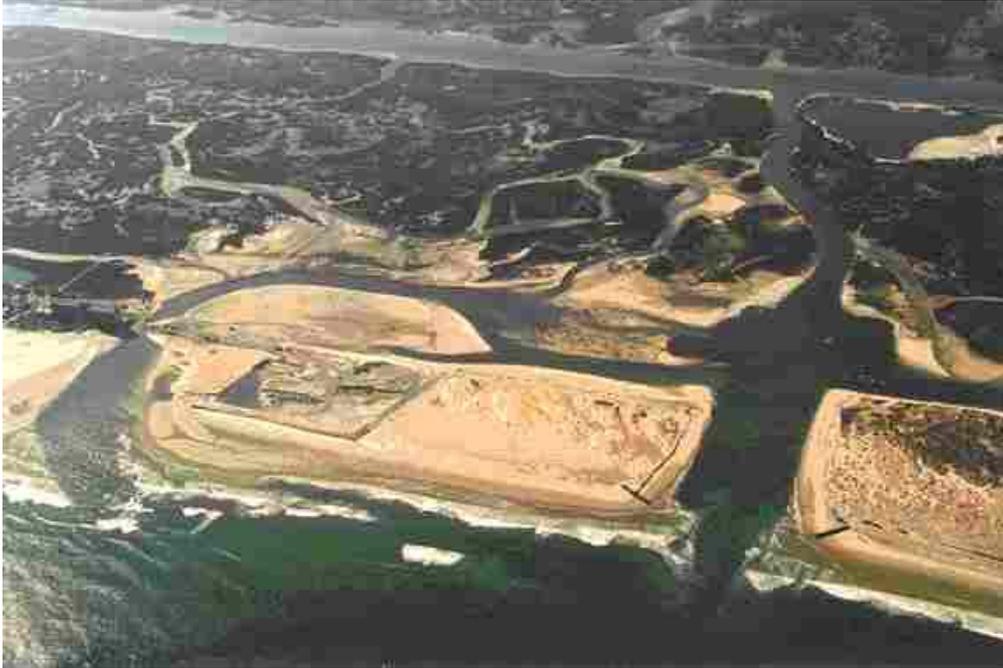
Fig. 5. Mason Inlet one week after inlet opening (photograph March 14, 2002).

The new Mason Inlet channel was opened on March 7, 2002 during a neap tide phase with the temporary sheet pile removed just prior to the beginning of an ebb tidal cycle. The following day, the Mason Creek channel, plugged by a 60 m (200 ft) unexcavated section, left in place to prevent extreme currents during the initial inlet opening, was dredged. Initial tidal flows between Mason Creek and the AIWW exceeded 1.6 m/sec (5 ft/sec) and boats were advised to remain away from the area until the inlet channel stabilized. Within a week of the new inlet's opening, the outer ocean channel scoured to a depth of 1.5 m (5 ft), providing boaters an opportunity to use the inlet. An aerial photograph of the site taken one week after the inlet's opening (Fig. 5) shows the old and the new inlet channels. The original inlet channel was subsequently closed on March 14, 2002 when a bridge of sand was pushed from the sand

disposal site at the south end of Figure Eight Island across the narrowest section of the inlet throat. Sediment excavated from Mason Creek and placed within the 12 –acre, diked stockpile area, provided the primary source of material for the inlet infill operations. An additional 57,400 m³ (75,000 yd³) of sediment excavated from the sand trap was hydraulically placed along the oceanfront to construct a typical beach profile.

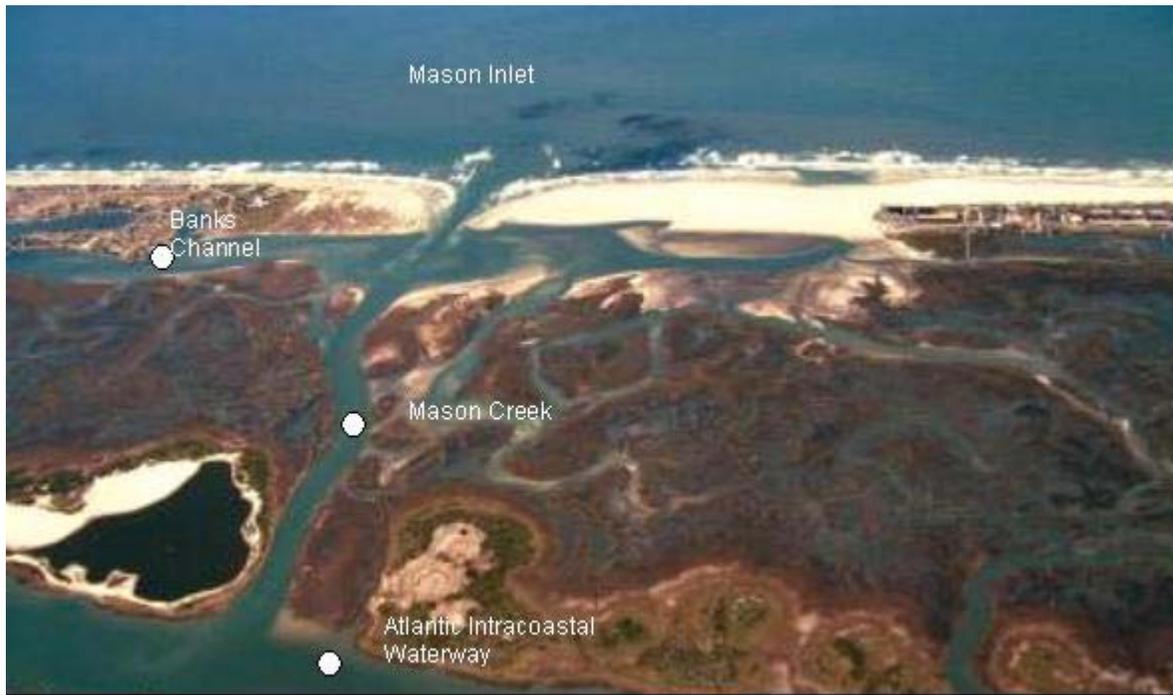
Fig. 6. Major morphologic features and three instrument locations.

To augment the County’s studies, the U.S. Army Corps of Engineers’ Coastal Inlets Research Program is supporting field studies to document development of the new ebb tidal shoal and to monitor circulation changes within the 3 affected tidal channels of the estuary (Fig. 6). These field investigations include periodic bathymetric surveys of the abandoned and new ebb-tidal shoals, and of the entrance and inlet channels; beach profile surveys; and measurement of current velocity and water surface elevation at three locations. Findings of these comprehensive monitoring studies will provide valuable data and information to guide future maintenance

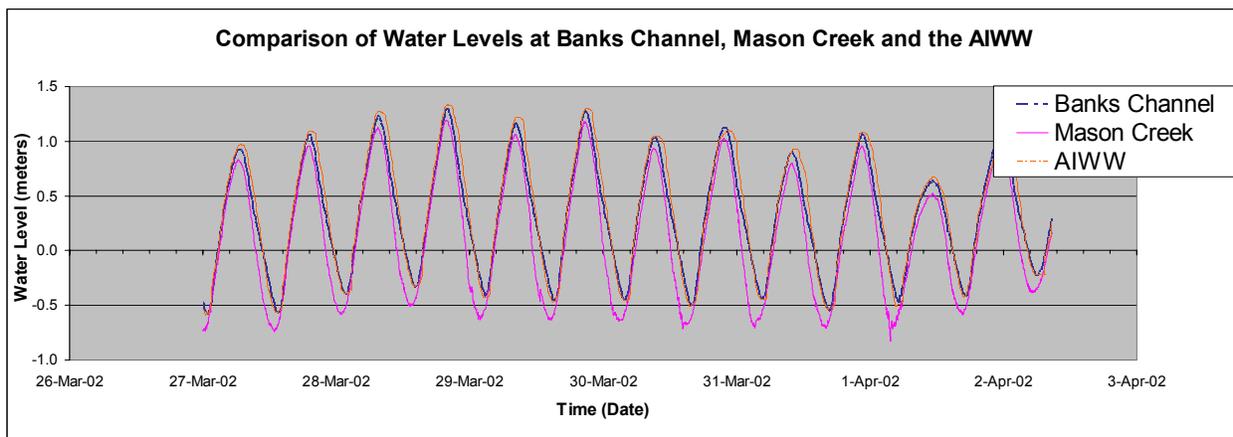
Fig. 7. Seven-day comparison of water levels during first spring tidal cycle after reopening of Mason Creek Channel and New Mason Inlet

Banks Channel and the AIWW are compared approximately 3 weeks after inlet opening during a spring tidal cycle. The ranges of water level were equivalent at 1.48 m at the Mason Creek and 1.52 m at the AIWW locations during this period of time, a 1-mi phase lag at the AIWW site was observed (Fig. 7). Currents within the reopened Mason Creek channel exceeded 1.5 m/sec (4.5 ft/sec) decreasing 6 months after the inlet's opening to a maximum a maximum of 0.5 to 0.7 m/sec (1.6 to 2. ft/sec) following initial equilibration of the channel cross-section occurring during the first 3 months (i.e., July 2002). October 2002 surveys show minor adjustment of the cross-section with maximum velocities remaining nearly equivalent based on observations of flow from June through December 2002 in Mason Creek. In contrast, Banks Channel has experienced a gradual reduction in velocities with significant shoaling along the southernmost 460 m (1,500 ft) inlet entrance section.

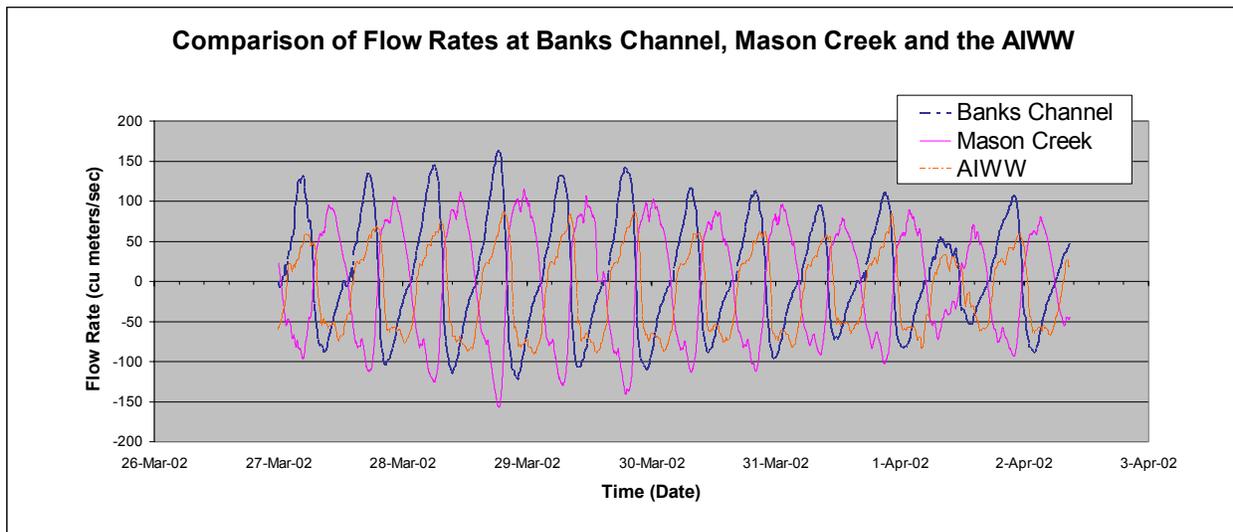
Fig. 8. Seven-day Comparison of Velocities 2 months after Reopening of Mason Creek Channel and New Mason Inlet (negative flow is west, or towards the AIWW)

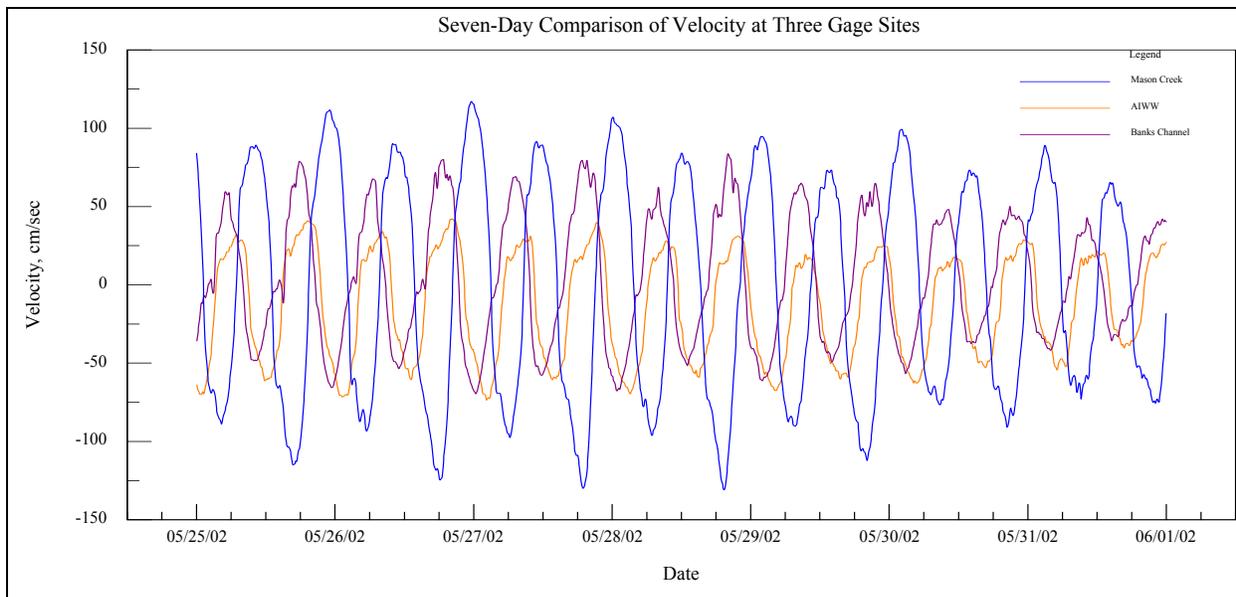
Fig. 9. Seven-day comparison of velocity after reopening Mason Creek (during spring tide)

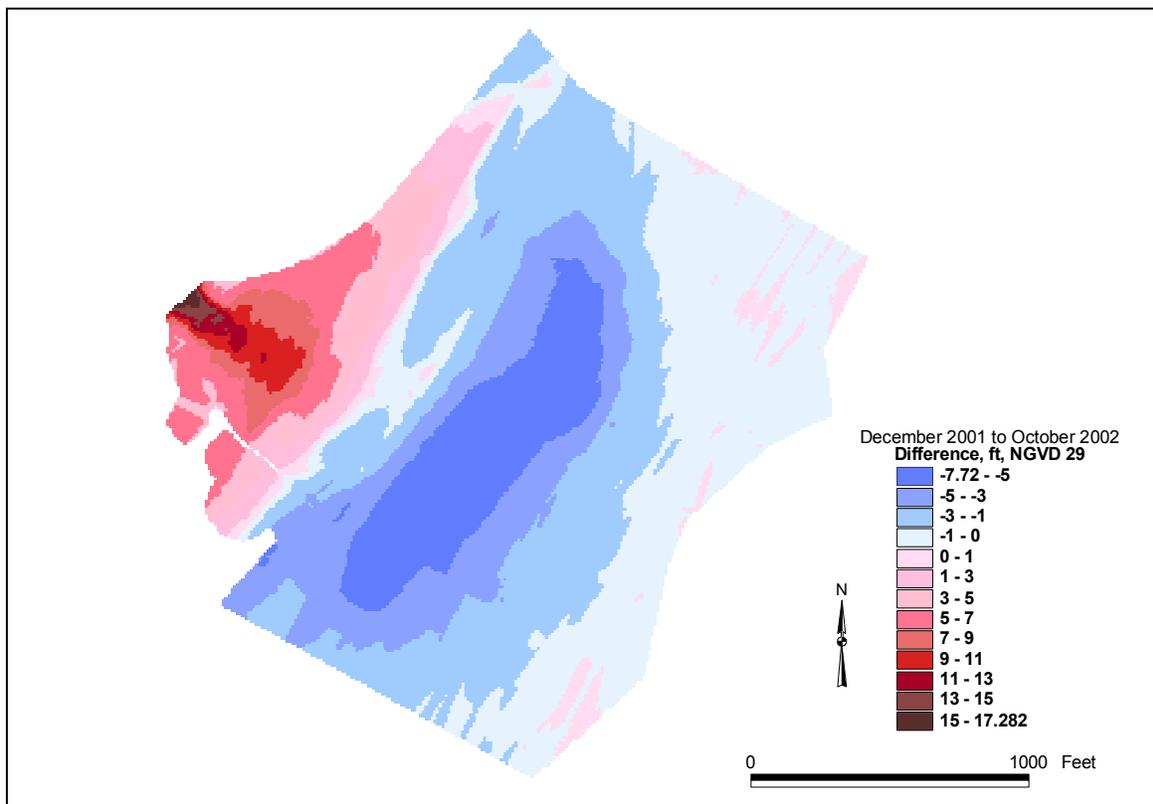
Fig. 10. Bathymetry change at original inlet, December 2001 to October 2002 (6 months post inlet closing).

The collapse of the ebb shoal at the original inlet entrance is of theoretical interest and was captured quantitatively in monitoring surveys (Fig. 10). Assuming that the bathymetry did not change substantially from the December 2001 survey until closing of the original inlet in early March 2002, the October 2002 survey allows a 6-month post-closing estimate of volume change to be measured. In Fig. 10, the volume change within above the 1-m contour was $130,000 \text{ m}^3$, with most of this sand reaching shore soon after the closing to form the long tidal pool.

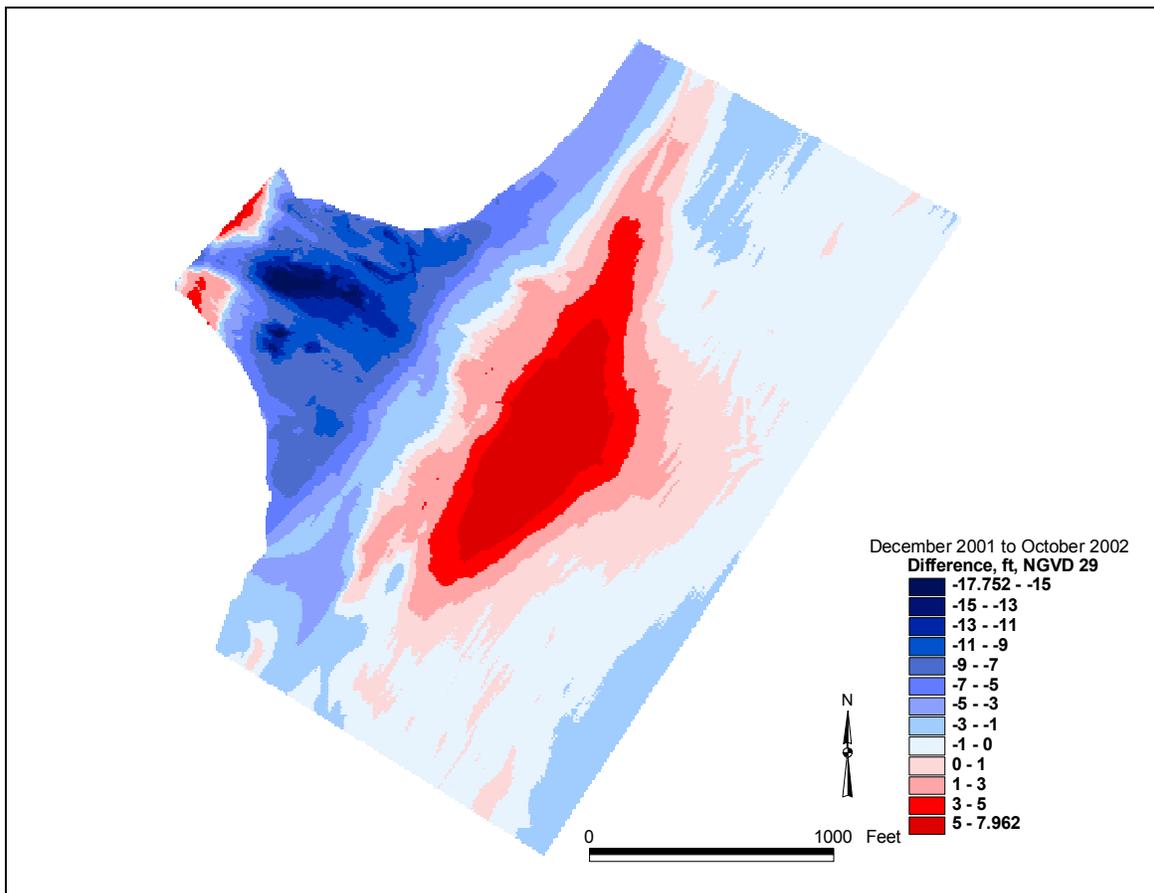
Fig. 11. Bathymetry change at new inlet, December 2001 to October 2002 (6 months post inlet opening).

Ebb Shoal of New Inlet. According to a predictive relation of Walton and Adams (1976), based on the calculated tidal prism the volume of the ebb shoal is expected to reach 0.9 to $1.2 \times 10^6 \text{ m}^3$ (1.2 to $1.6 \times 10^6 \text{ yd}^3$), at which time natural sand bypassing would be fully established. The monitoring program intends to capture growth of the ebb shoal. The 6-month post-inlet opening survey (difference shown in Fig. 11) gave a gain of $160,000 \text{ m}^3$ ($212,000 \text{ yd}^3$) above the .03-m

contour and 180,000 m³ above the zero contour. The ebb shoal was remarkably symmetric, suggesting balanced longshore sand transport or weak sand transporting capacity by waves for the 6-month period as compared to the tidal prism of the newly created inlet. It will be interesting to observe both the growth and symmetry of the ebb shoal at the new inlet.
